ROAD REPAIRS CARRIED OUT

COLONOSELCID

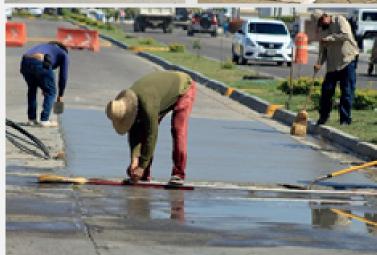
The repairs on roads have been an ongoing project, such as on Julio Berdegué Aznar Loop, where concrete slabs have been demolished, some leaks have been repaired, new water lines have been installed, and sewer drainage connections have been made, among other items. These steps were followed by backfilling, compacting, and pouring new concrete onto the sections repaired. These works have been carried out on sections such as on the Julio Berdegué Aznar Loop, by homes #80 and #93, as well as on La Tizona Street and the La Isla Section.

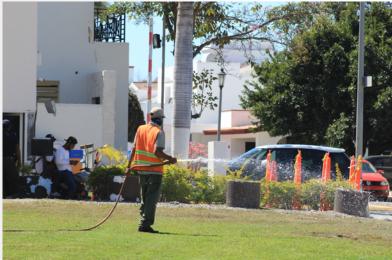
The cleaning, weeding, tree pruning, gardening and watering were carried out on green areas, medians, lots, navigation channels and docks bordering with the Marina, and the bio barrier.

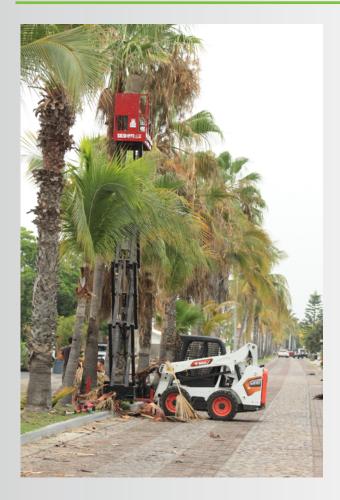
WEEDING AND PRUNING ON MEDIANS WAS ALSO DONE

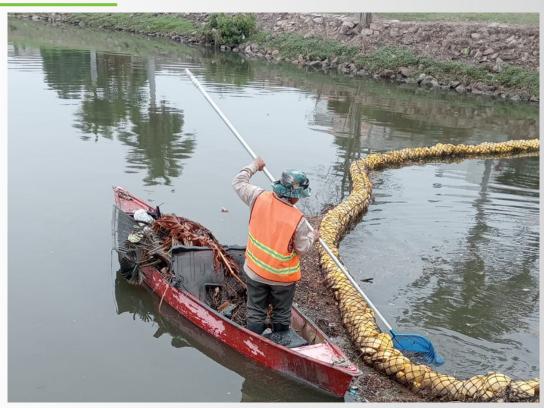
CLEANING DONE ON DOCKS, NAVIGATION CHANNELS AND BIO

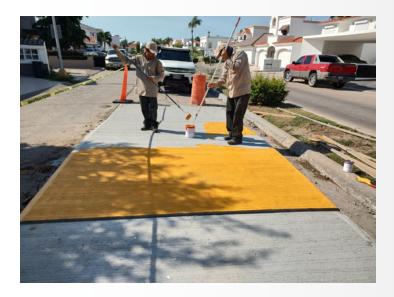
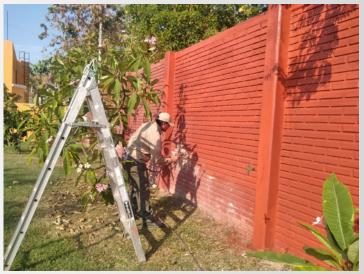
Painting done to the perimeter wall by La Colina Street, at the El Toreo section, also to the guard houses at El Ancla, Toreo, Club House, Corporate offices, curb returns, pedestrian and golf carts crossings, among other items.

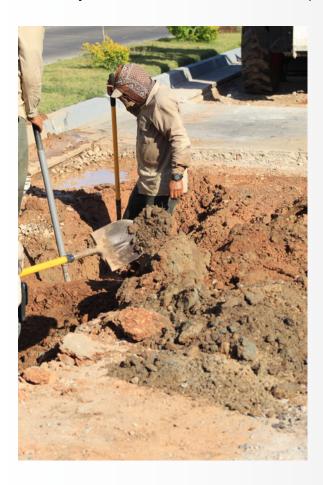
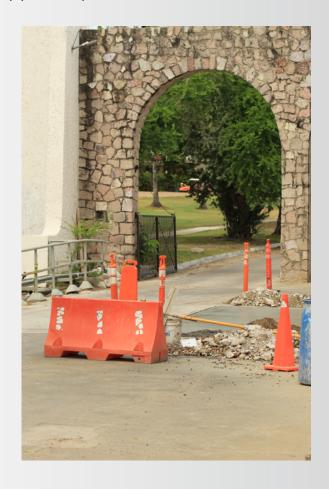
WATER LEAKS WERE REPAIRED AND DESILTING DONE

In the period from June to November, 23 leaks were repaired, of which, there was a major leak located at the La Isla section by the Stone Arch, where a section of potable water pipe was repaired, and a new valve was installed.

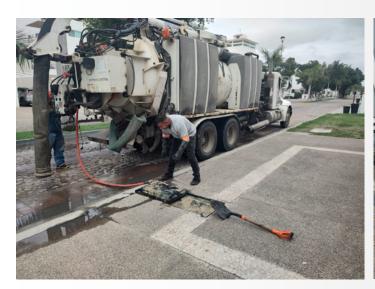
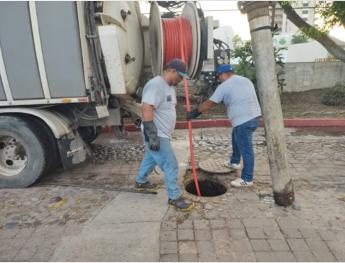
DESILTING DONE ON DRAINS

and manholes, storm drain cleaning, including garbage removal and desilting using pressurized water to wash away mud and remove garbage from the storm drains.

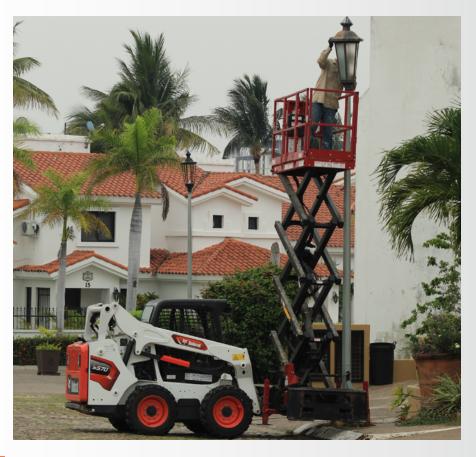
Maintenance and electric items were repaired at several guard houses and common areas at the residential complexes of the HOA, Unión de Colonos, as well as the light posts in the development.

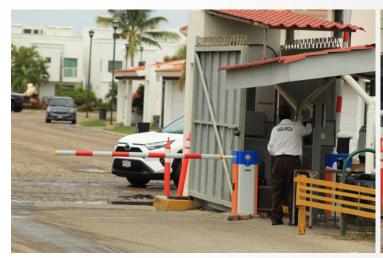
Installation of new barriers at the suppliers' guard house for better control of the incoming and exiting traffic.

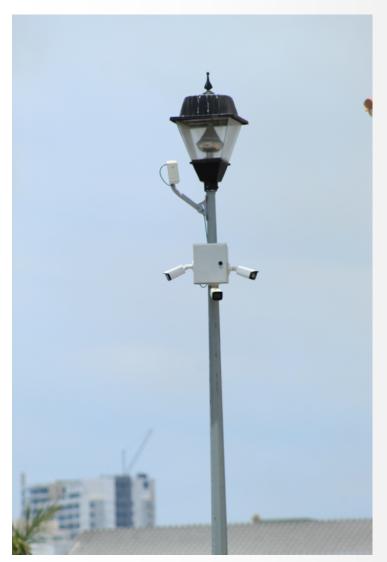
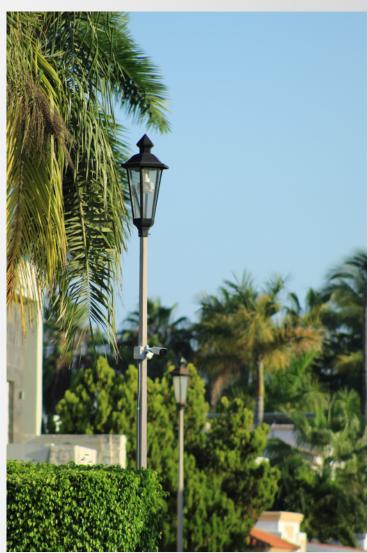
SURVEILLANCE CAMERAS WERE INSTALLED AT JOSÉ VELASCO AND DOÑA XIMENA STREETS
